## Reduction of transmitted impact noise rapport Extreme

The aim of the tests is to determine the reduction of transmitted impact noise. The full test results are given in test report A 3016-1E-RA dated January 12th, 2016 where a description is given of the standards and guidelines, the measurement situation, the measurement method, measurement accuracy and environmental conditions.

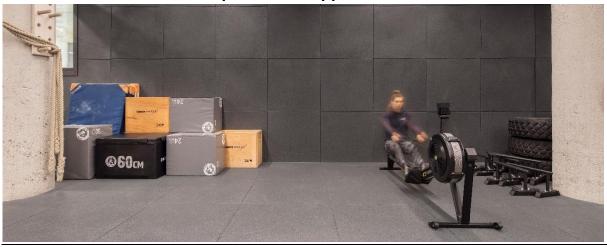
Product photo:

Article number:	32016
Dimensions	32010
Dimensions:	1000x1000m
Thickness:	20mm
Mass:	17,45kg.
measured reduction of	ΔLlin = 10 dB
transmitted impact noise	$\Delta$ Lw = 21 dB
,	The test result is presented in the figure on page 2

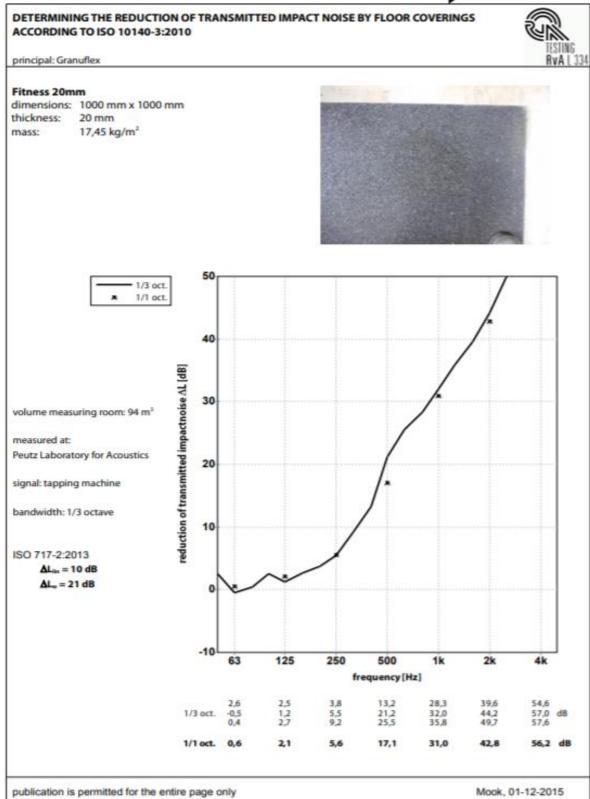
## LABORATORY FOR ACOUSTICS

The test result is presented in the figure on page 2.
