Reduction of transmitted impact noise rapport Extreme Impact

DETERMINING THE REDUCTION OF TRANSMITTED IMPACT NOISE BY FLOOR COVERINGS ACCORDING TO ISO 10140-3:2010

Bos Extreme Impact

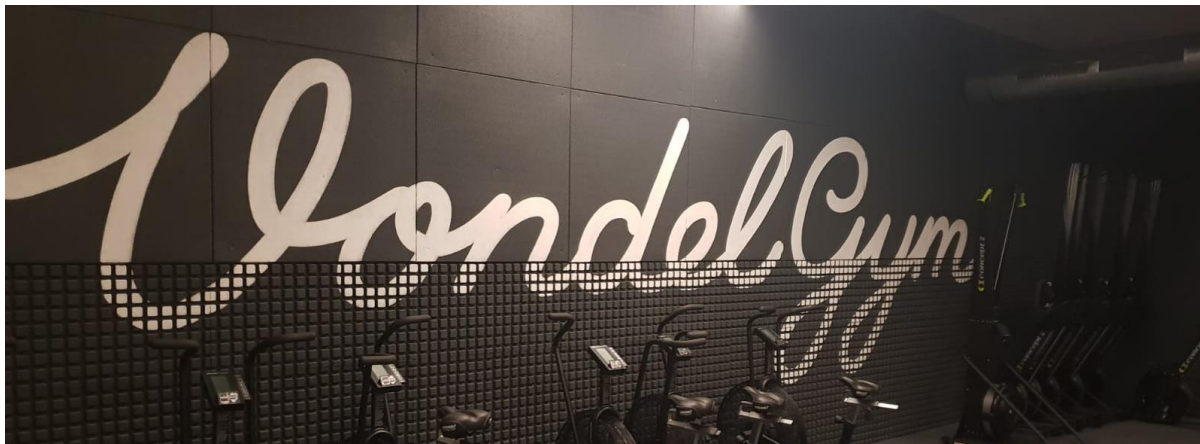
Product photo:

Article number:	32016
Dimensions:	1000x1000m
Thickness:	43mm
Mass:	26,20kg.
measured reduction of transmitted impact noise	$\Delta L_{lin} = 12 \text{ dB}$ $\Delta L_w = 24 \text{ dB}$
	The test result is presented in the figure on page 2.

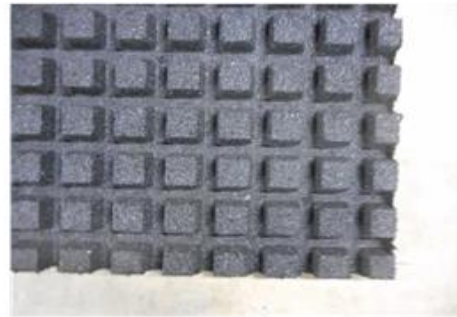
dimensions: 1000 mm x 1000 mm
 thickness: 43 mm
 mass: 26,20 kg/m²

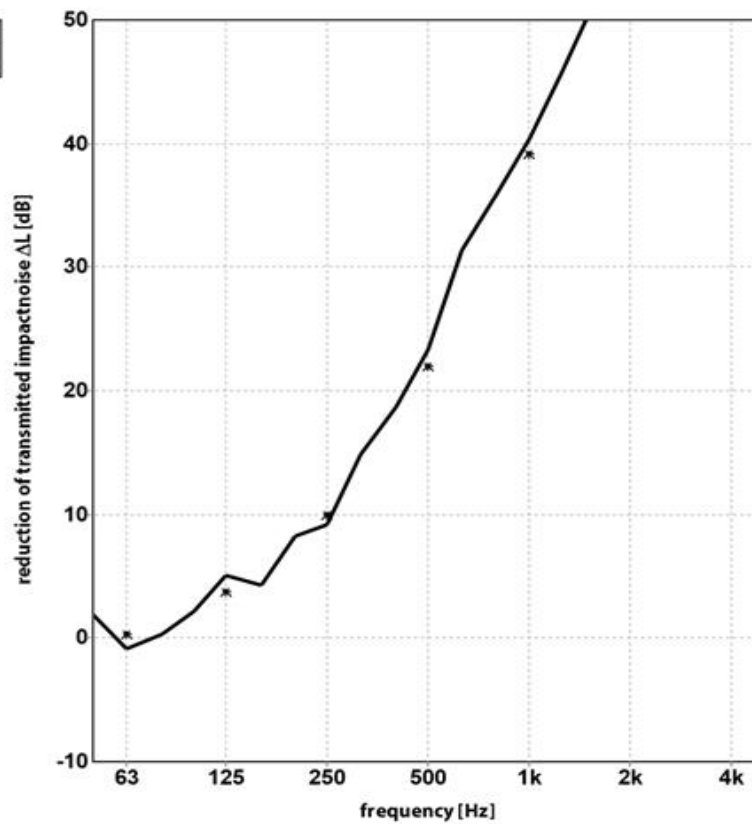
volume measuring room: 94 m³

measured at:
 Peutz Laboratory for Acoustics

signal: tapping machine

bandwidth: 1/3 octave

ISO 717-2:2013

$\Delta L_{lin} = 12$ dB

$\Delta L_w = 24$ dB

— 1/3 oct.
 * 1/1 oct.

1,9	2,2	8,2	18,7	36,0	51,9	62,2
1/3 oct.	-0,9	5,1	9,1	23,3	40,4	55,4	61,7
	0,3	4,3	14,8	31,4	45,6	58,2	59,8
1/1 oct.	0,3	3,7	9,9	22,0	39,1	54,4	61,1
